An Innovative Technique for Smart Repair of Induction Motors

Abstract—This paper introduces an innovative solution to tackle three-phase induction motor winding breakdown and repair issues through a three-step strategic approach. First, simulation-based models are used for the precise design of induction motors, especially the windings, providing a solid foundation for accurate winding repairs. This ensures innovative motor repair, enhancing key performance indicators of machines such as efficiency, power density, and power factor. Second, our proposal integrates health monitoring during the rewinding process, incorporating sensors at critical locations like windings and the core. Real-time temperature and vibration monitoring through an IoT-based platform enable proactive maintenance, preventing breakdowns and promoting overall motor health. Particularly relevant in Nepal, where traditional motor maintenance practices lack engineering solutions, this holistic model will revolutionize motor design, repair, and maintenance, offering a transformative solution for improved reliability in the industrial landscape.

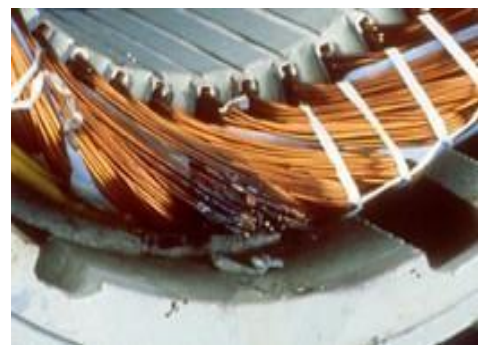
Fig. 1. Burnt winding due to stator winding fault [4].

According to IEEE, more than 42% of the faults in induction motors are bearing-related faults. Similarly, about 28% of the faults are related to the stator winding whereas less than 10% are related to the faults in the rotor of the machine. 22% are categorized as other faults [3]. Fig. 1 shows the damage in the motor caused by bearing fault and stator winding fault. Once the motor breaks down, the typical next step of any industry is to have the motor repaired in the minimum possible turnaround time from the workshop. Due to the emphasis given on the minimum turnaround time, the actual factory specification of the motor is often overlooked during the repair. Very few literatures are found that discusses the proper repair or refurbishment procedures or strategies. Some of the initial literature that presents a discussion on this issue dates back to the 1980s. For example, [5] discusses the repair and restoration of large induction motors considering the turnaround time. The paper presents a procedure to estimate the time and the cost of repair and discusses the general steps for inspection and repair of motors. The paper also presents several factors that are vital for decision making during the repair process. The authors in [6] presents the refurbishment of an induction motor for an application where the input voltage is lower than the nominal voltage of the motor. The paper presents general calculations of the motor parameters for the changed voltage level and the results show that the motor can be refurbished to achieve the rated speed even after reduced input voltage, by changing the

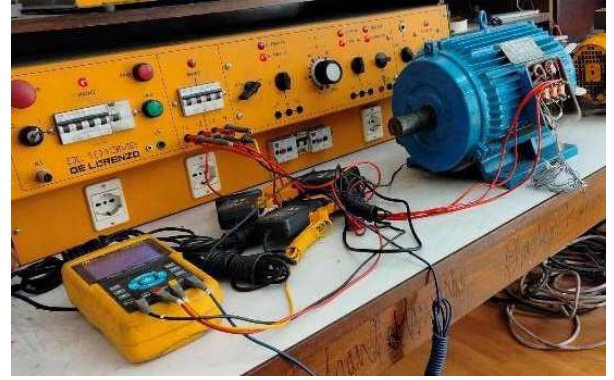
Fig 5. Laboratory set-up to test the refurbished motor.

The test machine was refurbished using the technique described in the previous sections. The refurbished machine was tested under no-load conditions as such loads of such high rating was not available in the laboratory. The machine was supplied with rated voltage and the sensor data was observed in real-time through the IoT platform. Figure 5 shows the The no-load speed of the motor was measured by using a digital tachometer as shown in Figure 6. The speed was measured to be 1495.5 rpm. The three-phase current of the motor was measured by using three split-core transformer (SCT-013) type current sensors, which has a sensitivity of 30mA/Ampere. The sensors

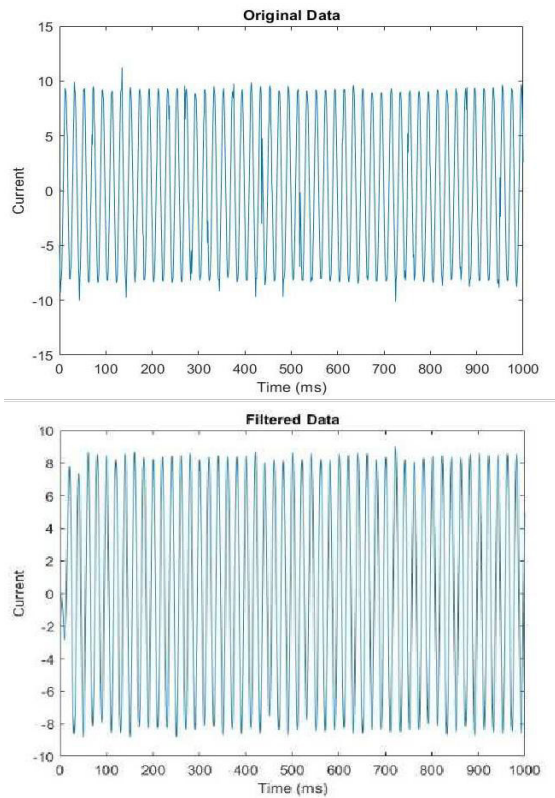
Fig. 7. Current in phase A before and after filtering.

were calibrated before being deployed. The currents were measured in real-time. The laboratory test set-up measured currents were further filtered to remove the noise. Figure 7 shows the current of one of the phases before and after filtering. Figure 8 shows the waveform of the three-phase currents as displayed in real-time in the ThingSpeak platform.
